Case study: Investigation of the fracture of low pressure steam turbine blade

Investigation in the fracture of low-pressure last stage turbine blade of 1.7 MW steam turbine which drives hydrogen compressor in Daura refinery- Baghdad- Iraq has been done to determine the reasons for this failure. The investigation has been performed in three ways: visual, mechanical, and chemical tests. The visual test showed pitting in the leading edge resulted from erosion-corrosion and these pittings had generated a crack that propagated and caused the fracture of the blade. Besides, mechanical tests showed an increase in material hardness and reduction in ultimate tensile stress and yield stress which reduced the strength of the material and made it more susceptible to fracture. Finally, the chemical test and microstructure showed that there is no change in the microstructure and chemical composition of blade alloy.

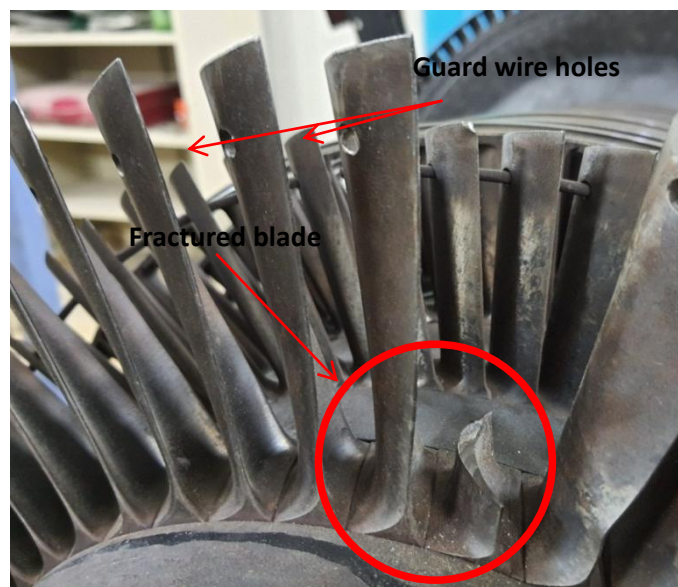
The investigation was undertaken to know the reasons for blade fracture in a 1.7 MW steam turbine which rotates at (10,000 rpm) after (60,000 hr) of work. It works as a driver for centrifugal compressor namely K201 which compresses hydrogen in power former unit (2) in Daura refinery- Baghdad – Iraq. The failure occurred at one blade in the last stage (12th stage) low pressure (LP) steam turbine. The fracture is located at (13 mm) from the root of the blade which is (95 mm) long as shown in figure (1). The material of the blade is X20Cr13 tempered martensitic chrome alloy steel. In addition, visual inspection showed that the guard wire which holds 15 blades from the top has been dislocated.

Figure (1) LP last stage turbine blade failure.

As a temporary solution to avoid a long shutdown of the unit and as there is no spare rotor, another blade has been cut 180° from the broken blade. Besides, a new wire guard has been installed and dynamic balance has been done to return the rotor to the service immediately. However, the broken blade area and the cut blade have been inspected to specify the reasons for this failure and to inspect the whole stage. The inspection included visual tests, chemical, and mechanical properties analysis to determine the reasons for the failure which caused a high vibration in the turbine and emergency shutdown in the equipment.

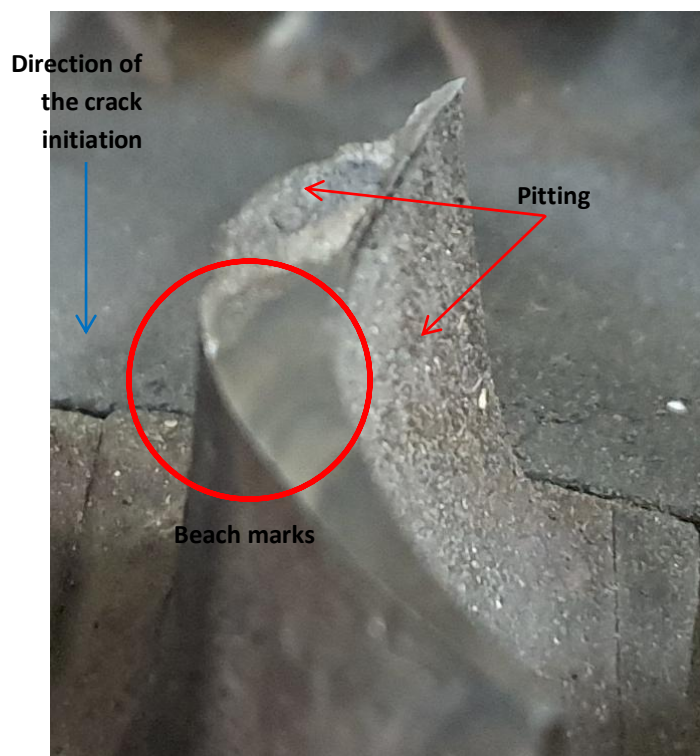
Visual inspection revealed that a crack has been propagated from the attack angle of the blade. On the area of broken blade beach marks and pitting on the blade attack angle and broken surface have been noticed as shown in figure (2). The guard wire holds 15 blades in the stage which consists of 50 blades noticed to be missing and dislocated from its place.

Figure (2) Beach mark on broken surface

1. The visual test showed pitting due to erosion-corrosion on the leading edge on all last stage turbine blades. These pitting led to crack initiation and propagation as beach marks showed that the crack initiated from the leading edge and propagated to the trailing edge and caused the blade fracture.

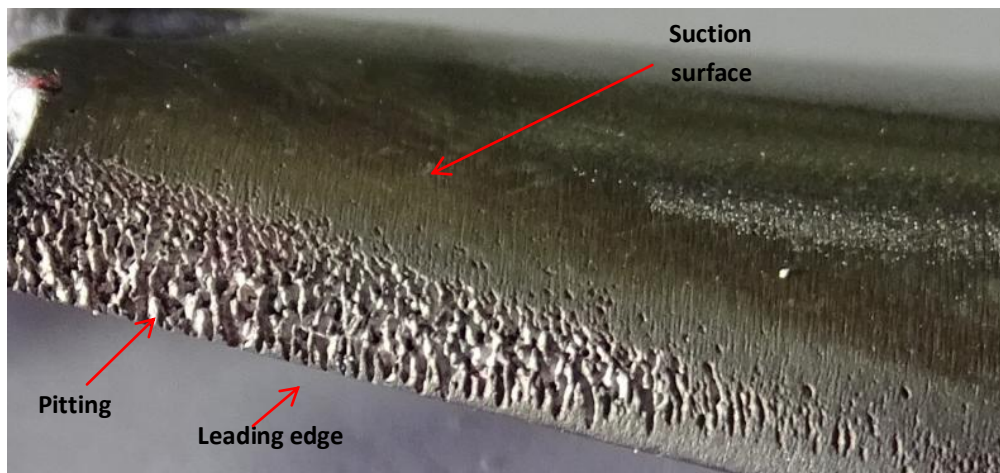
Also, deep pitting has been noticed on all blades of the 12th (last stage) of the turbine along the leading edge of the blades at the suction surface (figure 3). These pitting are a result of erosion-corrosion on the blade surface. This could be an indication that crack has been propagated from the pitting area that caused stress corrosion cracking (SCC) which is common in low-pressure turbine blades [12].

Figure (3) Pitting along the leading edge turbine blade.

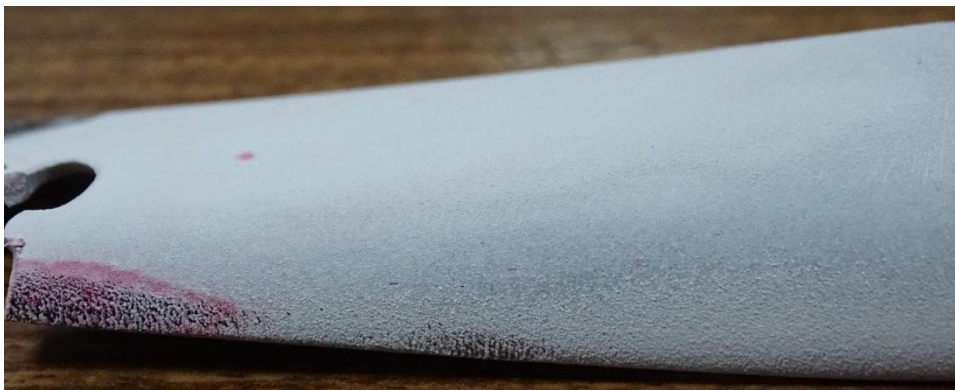
Furthermore, penetration test has been performed to inspect blade for other cracks that may exist. The tests showed no other cracks has been existed on the un-fractured blades in the last stage of the steam turbine as shown in figure (4).

Figure (4) penetration test show no further cracks on blade.

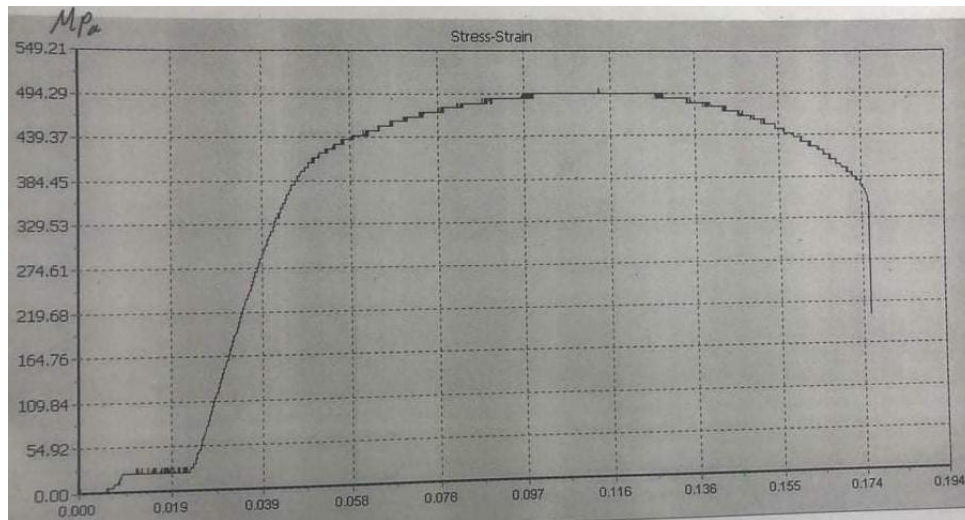
Tensile test results showed that there is a noticeable decline in ultimate, yield, and feature stress. The ultimate tensile stress has been dropped from 700 Mpa to 500 Mpa (reduction 28%) while the yield stress has been decreased from 500 Mpa to 385 Mpa (reduction 23%) figure (5).

This significant deterioration in mechanical properties could be due to long working hours which is 60,000 hrs as the steam turbine blades are susceptible to high temperature and stress levels [14]. In addition, turbine blades are subjected to pressure fluctuation due to the flow of steam which causes vibratory stress and these fluctuations in loads will result in high-stress concentrations especially in blade root in addition to pitting that initiate the crack [3,18].

Figure (5) Stress-strain curve for blade material

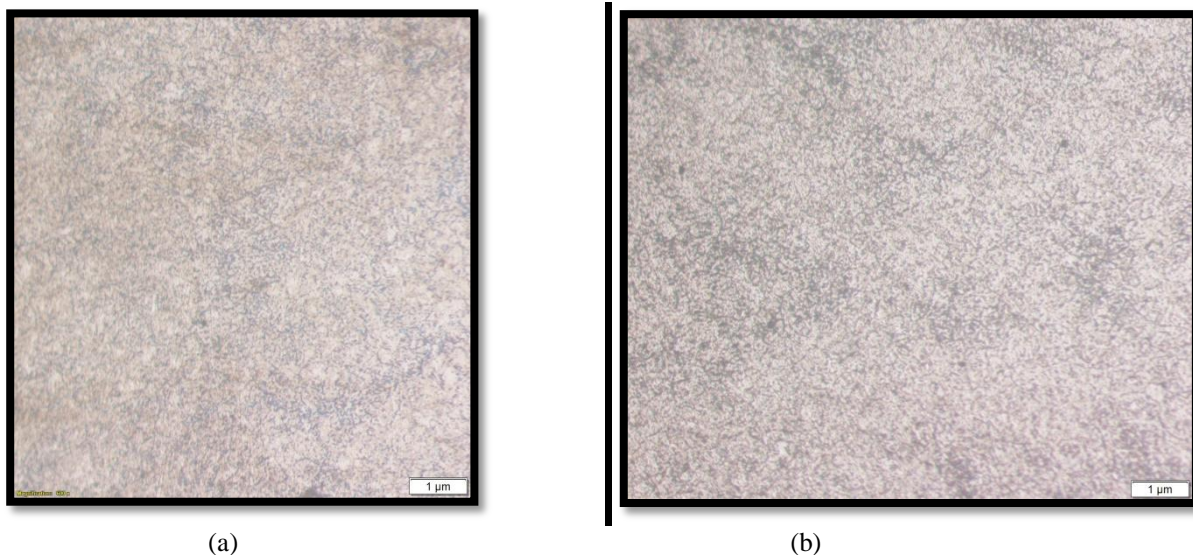
Regarding the microstructure investigation, two specimens had been inspected one on the pitting region and the other on the blade root region. Optical micrographs for both polished specimens showed normal homogeneous microstructure with no evidence of degradation in microstructure of the X20Cr13 martensitic stainless steel as shown in figure (6).

Figure (6) Optical micrograph at 600x of blade material (a) root region (b) pitting region
