## Natural Coastal Processes And Its Geo-Environmental Impact In The Area Between Chennai And Nagapattinam Coast Of Tamilnadu And Pondicherry

**ABSTRACT :** Natural coastal /marine processes affect the coastal areas making significant changes in the morphology and associated ecosystem. Geo-environmental appraisal of Tamil Nadu coast between Chennai in the north and Nagapattinam in the south was made by identifying the areas of impact due to ongoing dynamic changes along the coast. The various thematic data such as geological, geomorphological, landuse, ground water etc. was synthesized and field verified to arrive at regional impact assessment for the study area. Apart from sea erosion and progradation, other geological processes taking place in the study area include submergence, silting of lagoons, and growth of spits across tidal inlets and rivers, flooding, high wind, increased salinity/ iron content in soil and water. The information gathered can be an input in the formulation of remedial measures and effective utilization of coastal area resources.

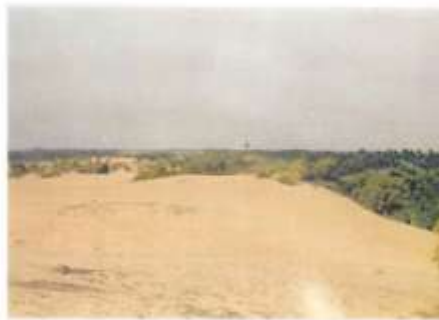
**Fig-1 High Dune complex at Muttukkadu near Marakkanam**

This sector is marked by the presence of 0.4 to 0.8 km wide dunes of varying heights. The dunes in the Palar river area are about 4 to 5 m height and about 400m wide. They gradually increase in height to attain 20 m and width of 800m at Muttukkadu village, located about 4.5 km NNE of Marakkanam( Fig 1), where after they lose their height and width rapidly. Tidal flats are quite wide in this sector attaining a maximum width 4 - 5 km and therefore support the Cheyyur and Marakkanam salt factories. The three lagoons present in this sector are the Cheyyur, Yedayantittukaliveli and Kaliveli lagoons. All of them trend parallel to the coast. The Kaliveli lagoon situated south of Marakkanam is cut off from the sea at present and as such has become a lake. This sector is flanked in the west by the pediplain formed over Archaean rocks uptoChunnambur and south of Chunnambur, by the pediplain formed over the Cuddalore Group of rocks of Tertiary age.

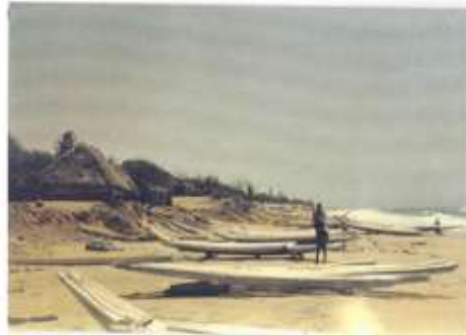
**Fig 2- Sea Erosion at Periyakuppam, South of Palar river mouth**

At present, sea erosion is observed in the areas immediately north and south of the river mouth over lengths of 3.5 km and 1.5 km respectively. The erosion is intense over these stretches and continues southward upto Kuppam at a reduced intensity. The villages located south of the river, viz; Chinnakuppam, Periyakuppam and Alikuppam experience severe sea erosion. Periyakuppam and Chinnakuppam are the worst affected villages with an average annual rate of about 2.0m (Fig 2). The process continues even today.

Erosion in this sector is caused due to the combined action of reduced sediment supply by the Palar river (ephemeral river with only a few days of surface water flow in peak rainy season ), growth of a spit across Palar river mouth and possibly also due to neo-tectonic movements. A few Submarine valleys are also interpreted off Palarriver which may be trapping the littoral sediments. The disposition of coastal dune between Palar river mouth and Alamparai tidal inlet shows that the dunes gradually gain height towards south, from 4 m at Palar river mouth to 20 m at Muttukkadu, near Marakkanam. Excepting the height difference, the dunes do not differ in their characteristics. This rise could be due to a slow up warping of the coastal area in this part as a result of which the southern side was raised while the northern side near Palar river mouth was lowered. Consequently, areas around the Palarriver mouth experiences erosion as per the probable inference made in this study.

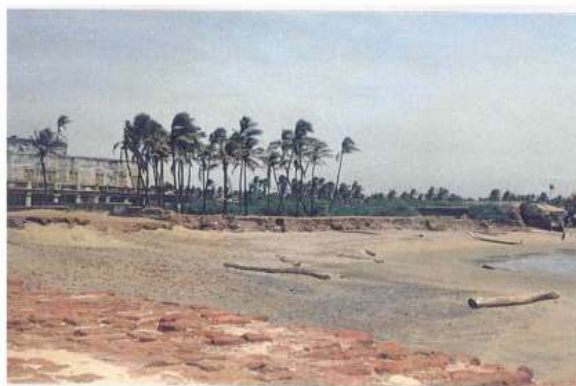
**Fig-3 Sea erosion at the Danish Fort- 'Danesborg'- Tarangambadi**

Incidence of sea erosion at Tarangambadi for three centuries (17th to 19th) were referred to in various records of the Danish Settlement, East India Company and British India. The Danish Fort- 'Danesborg'- at Tarangambadi (Fig -3) was built in 1626. A battery stood at 300 feet (about 90m) east of the fort wall. In early 1750 a larger part of the fort was washed away. It is mentioned that during the 17-18th century the sea was 400 - 500 feet away from the sea line in 1850. Presently the sea is close to the east wall of the fort. Further evidence for erosion at Tarangambadi comes from the Masilamani temple, built during 10th century. The temple is located about 150 m north of the fort. It had been consistently attacked by the waves. Its tower had fallen due to sea erosion in 1859, and presently, the temple has been brought down by the sea (Fig-4). At Tolamtondi the severity of sea erosion in this area is unquestionable because it is only in this stretch anywhere south of Chennai that protective embankments have been constructed to ward off sea erosion. Even these embankments have been breached at places.

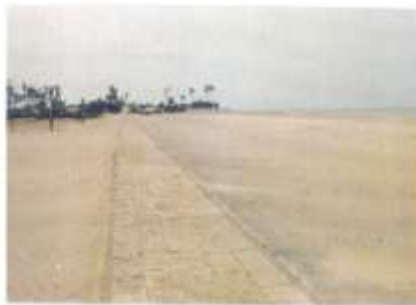
**Fig-5, Protective embankment –North of Karaikal**

Geological evidences in support of submergence of coast include absence of beach dunes, low flat coast, and breached dunes. The 3-4 m high, circular to elliptical, discontinuous dunal mounds from Santirapadi to Kilinjimedu would have been a continuous beach dune in the past. Yet, in course of time, this once continuous body of dunes was breached at a number of places along the 5.5 km stretch. At present, the dunal mounds occupy a length of only 2.0 km and the remaining 3.5 km has been cleared of dunes due to breaching by sea water ( **Plate 3** ). Protective embankments (Fig-5) were built along the breached sections. Even these embankments were breached at places. Also, the sea water during storms has flowed across these embankments inundating the agricultural field to further west.

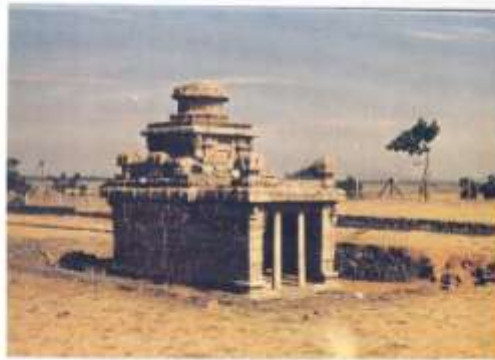
**Fig-6 Mukundanayanar Temple at Mahabalipuram and a view of sand accretion**

Large scale sand accretion had also taken place in Mahabalipuram area in the past as inferred from various sites. Till its restoration in its recent times the Mukundanarayanar temple (ninth century A.D. temple) in the northern part of the town partly remained under 3-4 m thick dunal sand resulted from sand accretion ( Fig-6) . Similarly, the five rathas monument also remained partly under 2-3 m dunal sand. The sand accretion had occurred due to high energy winds in the past.

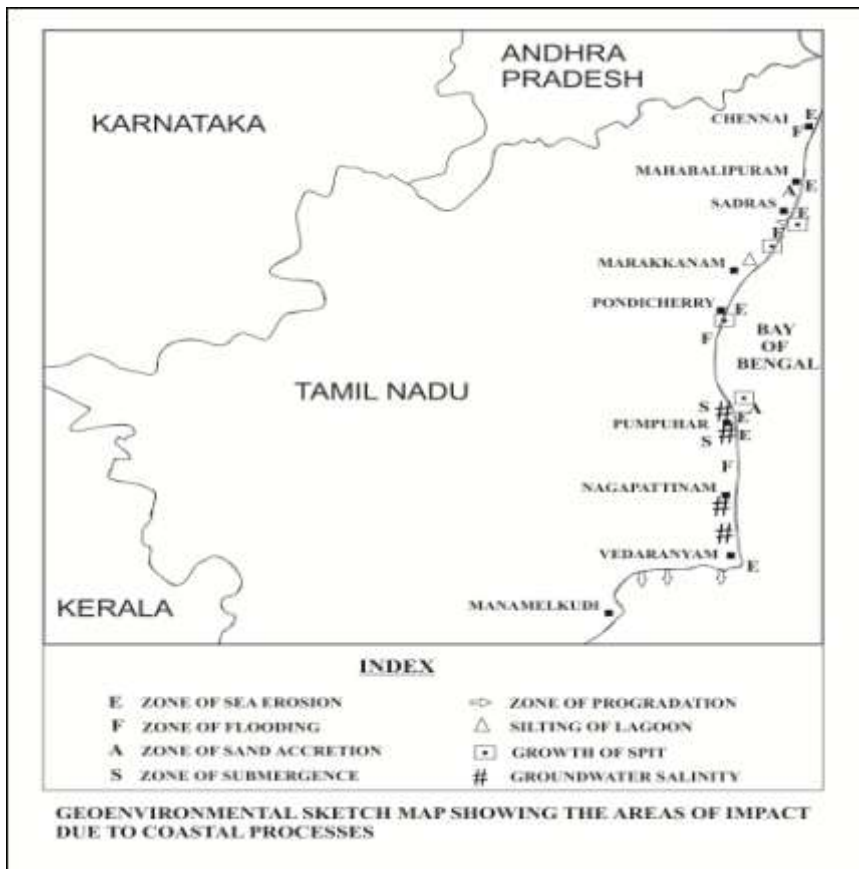
**Plate-4**

A larger part of the Tamil Nadu coast has not shown any remarkable or significant spatial changes over the last 40 - 70 years. This is inferred from toposheets and satellite imageries of different periods thereby implying that the shore line has not experienced large scale changes but remained mostly neutral. Yet, sites of sea erosion and progradation are not uncommon (Krishnan and Srinivasan 1998). In the coastal tract between Chennai and Nagapattinam, progradation is observed at the mouths of Vellar, Coleroon, Uppanar near Tirumullaivasal, Ambanar, Cauvery and Tirumalairajan rivers. Sea erosion is noted at north of Mahabalipuram, Palar river mouth, Pondicherry and the 35 km long stretch between Tirumullaivasal and Karaikal in the south. Apart from sea erosion and progradation, other geological processes taking place in the study area include submergence, silting of lagoons, and growth of spits across tidal inlets and river mouths, flooding, high wind, high salinity and high iron content in soil and water etc. Each of these processes and their impacts on coastal environment are detailed below and depicted in the **Plate4**.
